U.S. 412: from I-35 in Noble County, Oklahoma to I-49 in Benton County, Arkansas

Planning and Environmental Linkages Study

Traffic, Safety and Engineering Constraints Report

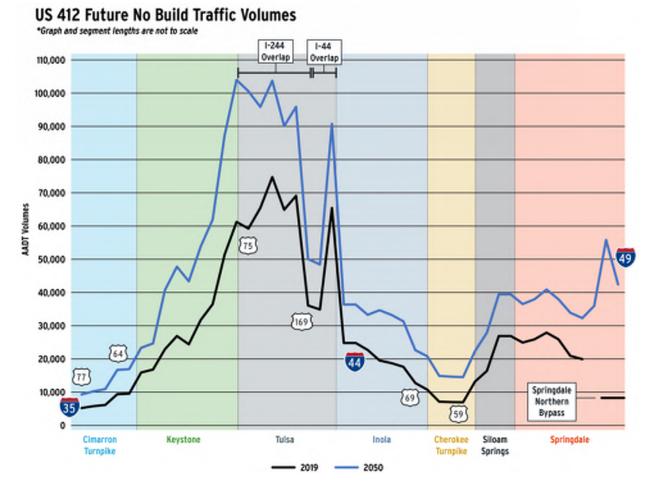
Figure 3: U.S. 412 Future No Build Traffic Volumes

Figure 3 displays future no-build traffic volumes across the corridor for 2050, along the seven planning segments.

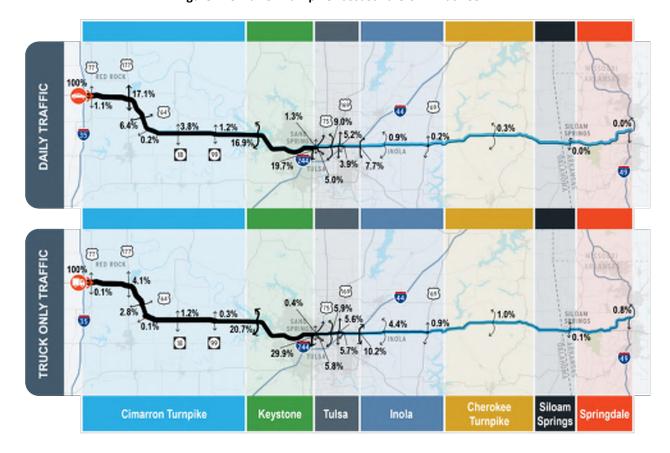
Figure 4: Cimarron Turnpike Eastbound U.S. 412 at I-35

Based on the OD data, drivers entering the U.S. 412 corridor from the western limit and I-35 exit at three main locations, as shown in Figure 4. 19.7% of drivers exit at I-244, south of U.S. 412, 17.1% of exit at U.S. 177, and 16.9% exit at Highway 99 and I-244.

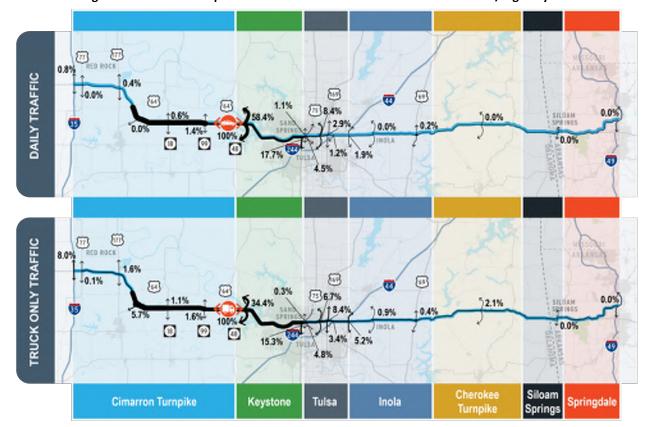
Figure 5: Cimarron Turnpike Eastbound and Westbound U.S. 412 at U.S. 64/Highway 48

Based on the OD data, 58% of all drivers entering the U.S. 412 corridor at U.S. 64 and Highway 48 exit between Highway 99 and I-244, as shown in **Figure 5**. 17.7% of drivers exit at I-244, just south of U.S. 412.

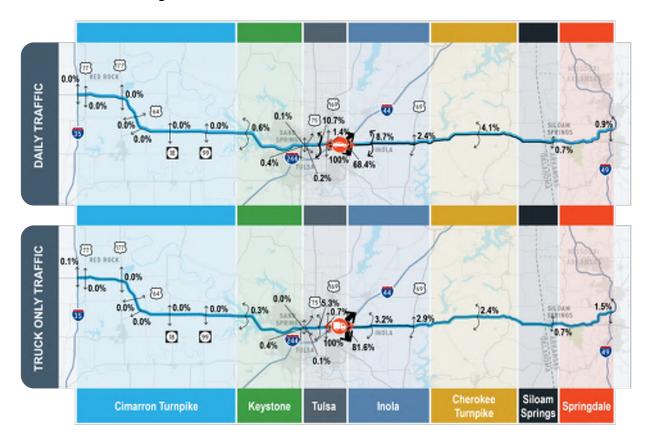
Figure 7: Tulsa Eastbound and Westbound U.S. 412 at I-44 South

Based on the OD data, over 68% of all drivers entering the U.S. 412 corridor at the I-44 exit, south of U.S. 412, as shown in **Figure 7**. Another 11% exit between U.S. 75 and U.S. 169.

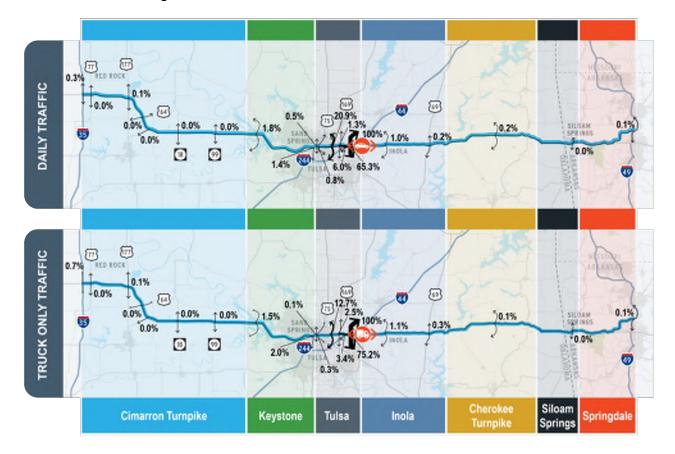
Figure 8: Tulsa Eastbound and Westbound U.S. 412 at I-44 North

Based on the OD data, over 65% of all drivers entering the U.S. 412 corridor at the I-44 exit, north of U.S. 412, as shown in **Figure 8**. Another 21% exit between U.S. 75 and U.S. 169.

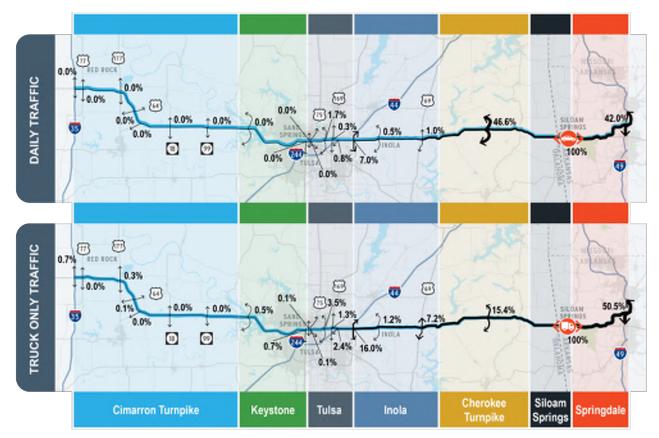
Figure 10: Siloam Springs Eastbound and Westbound U.S. 412 at Highway 59

Based on the OD data, 46% of all drivers entering the U.S. 412 corridor at Siloam Springs exit between U.S. 69 and Siloam Springs, as shown in **Figure 10**.

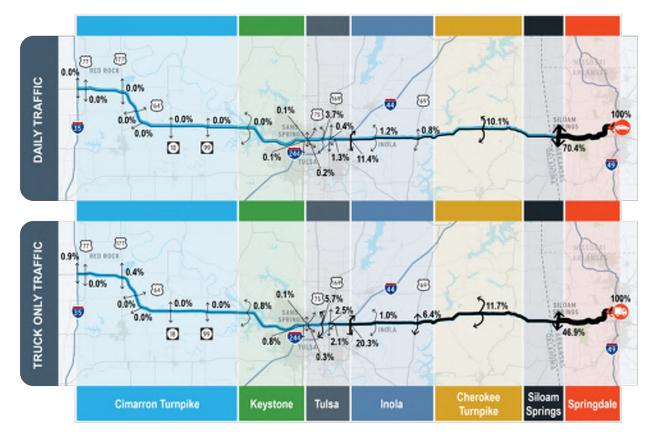
Figure 11: Springdale Eastbound and Westbound U.S. 412 at I-49

Based on the OD data, 70% of all drivers entering the U.S. 412 corridor at I-49 exit at Siloam Springs, as shown in **Figure 11**.

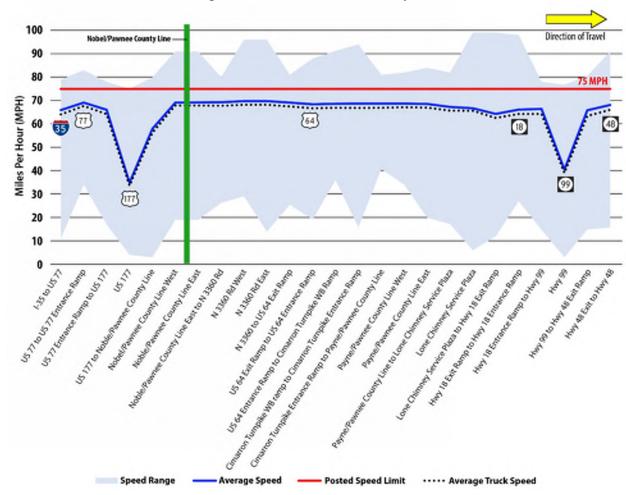
Figure A- 1: Cimarron EB AM Travel Speeds

Eastbound morning peak period traffic between the hours of 7 AM and 9 AM. Speeds for both passenger vehicles and trucks consistently stay 5-10 mph below the posted speed limit of 75 mph and closely mirror one another across the full length of the segment, with significant drops in speed at U.S. 177 and State Highway 99 due to toll plazas.

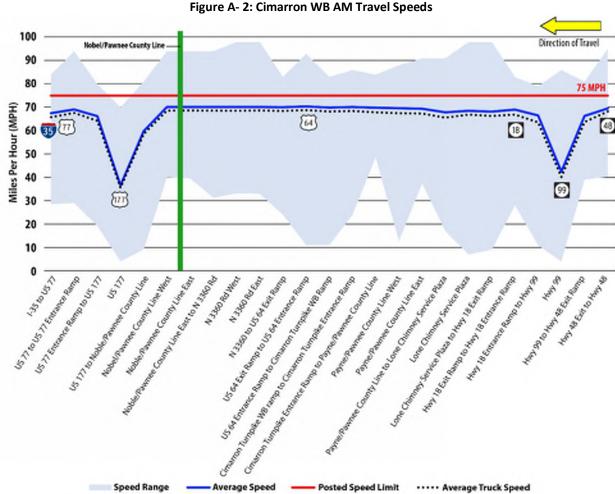
Westbound morning peak period traffic between the hours of 7 AM and 9 AM. Speeds for both passenger vehicles and trucks consistently stay 5-10 mph below the posted speed limit of 75 mph and closely mirror one another across the segment, with significant drops in speed at Highway 99 and U.S. 177 due to toll plazas.

The average passenger car and truck speed along the Cimarron Turnpike in the westbound direction during the AM peak hour is between 40 and 65 mph from Highway 48 entrance ramps to Highway 99 to Highway 18 exit ramp. Speeds recover to an average of 70 mph, 5 mph below the posted speed of 75 mph, between Highway 18 exit ramp and the Noble/Pawnee County Line West. Speeds range from 40 to 70 mph between the Noble/Pawnee County line west to the Highway 177 to U.S. 77 Exit ramp. The data shows that westbound speeds range from 5 to 95 mph for the entire segment.

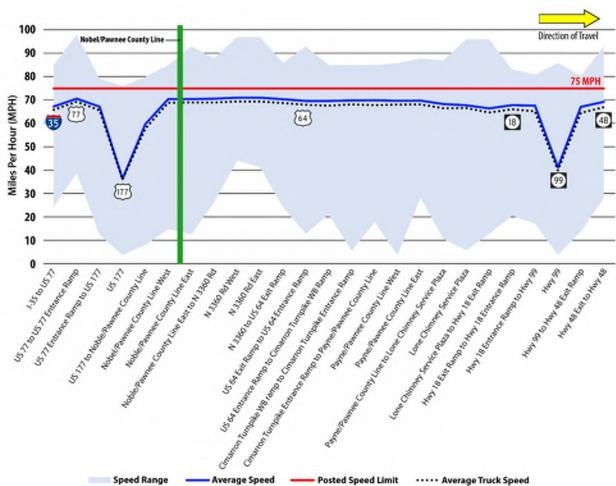
Figure A- 3: Cimarron EB PM Travel Speeds

Eastbound evening peak period traffic between the hours of 4 PM and 6 PM is shown below. Speeds for both passenger vehicles and trucks consistently stay 5-10 mph below the posted speed limit of 75 mph and closely mirror one another across the full length of the segment, with significant drops in speed at U.S. 177 and Highway 99 due to toll plazas.

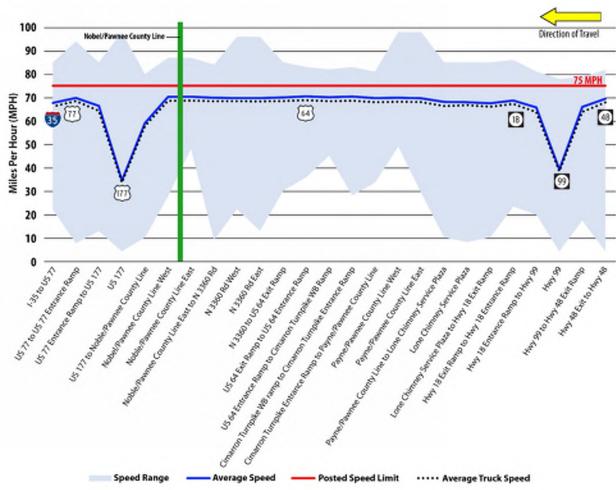
Figure A- 4: Cimarron WB PM Travel Speeds

Westbound evening peak period traffic between the hours of 4 PM and 6 PM is shown below. Speeds for both passenger vehicles and trucks consistently stay 5-10 mph below the posted speed limit of 75 mph and closely mirror one another across the full length of the segment, with significant drops in speed at Highway 99 and U.S. 177 due to toll plazas.

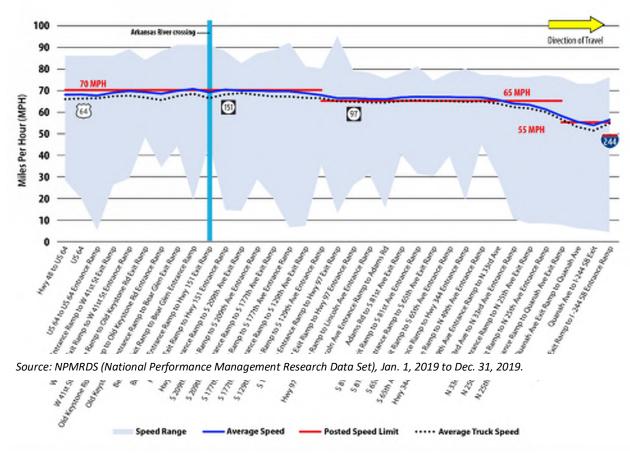
Figure A- 5: Keystone EB AM Travel Speeds

Eastbound morning peak period traffic between the hours of 7 AM and 9 AM is presented in this section. Speeds limits vary from 55 mph to 65 mph to 70 mph. Passenger vehicles travel just above the speed limit in the 65 mph section. Truck speeds are slightly slower than the passenger vehicle speeds but follow the similar speed patterns.

The average passenger car and truck speed along the Keystone segment in the eastbound direction during the AM peak hour remain steady at around the 65 mph posted speed limit until the speed limit lowers to 55 mph at N 25th Ave entrance ramp/Quanah Ave exit ramp. From I-244 SB exit ramp/I-244 NB entrance ramp to N 25th Ave exit ramp/N 25th Ave entrance ramp where speeds lower to the posted limit. The data shows that westbound speeds range from 5 to 95 mph for this segment.

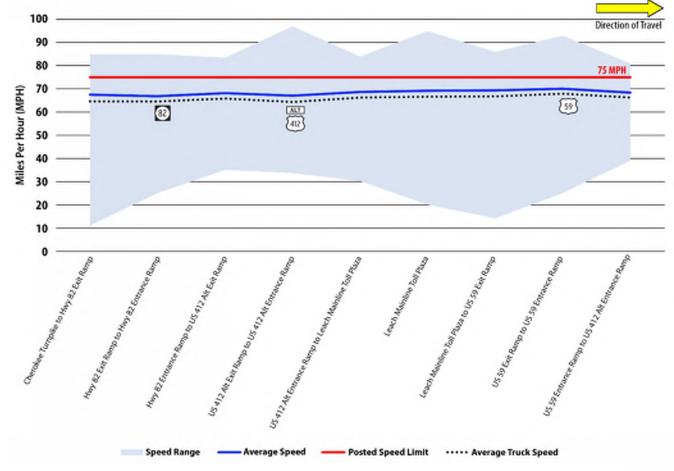
Figure A- 17: Cherokee EB AM Travel Speeds

Eastbound morning peak period traffic between the hours of 7 AM and 9 AM is presented in this section. The posted speed limit in the Cherokee segment is 75 mph. Passenger vehicle and truck speeds remain steady at around 70 mph along the entire segment. Truck speeds are roughly 2 mph slower but follow the same increase or decrease in speed as passenger vehicles.

The average passenger car and truck speeds along the Cherokee Turnpike in the eastbound direction during the PM peak hour is between 68 and 70 mph from Cherokee Turnpike/Highway 82 Exit to U.S. 59 entrance ramp/U.S. 412 Alt entrance ramp. The posted speed limit is 75 mph. The data shows that eastbound speeds range from 11 to 95 mph in this planning segment.

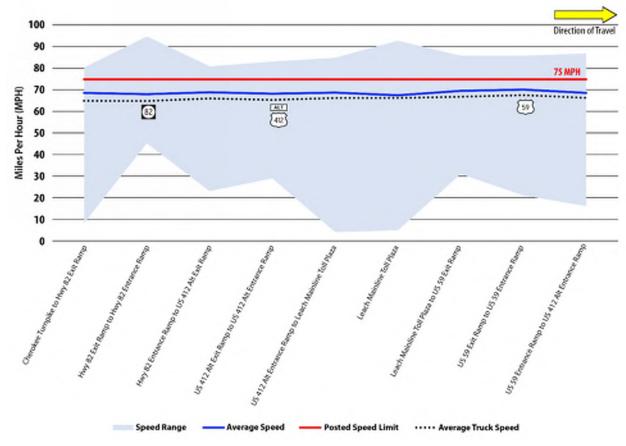
Figure A- 19: Cherokee EB PM Travel Speeds

Eastbound evening peak period traffic between the hours of 4 PM and 6 PM is presented in this section. The posted speed limit in the Cherokee segment is 75 mph. Passenger vehicle and truck speeds remain steady at around 70 mph along the entire segment. Truck speeds at the west end of the segment are approximately 66 mph and slightly increase to approximately 68 mph toward the east end of the segment.

The average passenger car and truck speeds along the Cherokee Turnpike in the eastbound direction during the PM peak hour is between 68 and 71 mph from Cherokee Turnpike/Highway 82 Exit to U.S. 59 entrance ramp/U.S. 412 alt entrance ramp. The posted speed limit is 75 mph. The data shows that eastbound speeds range from 9 to 95 mph.

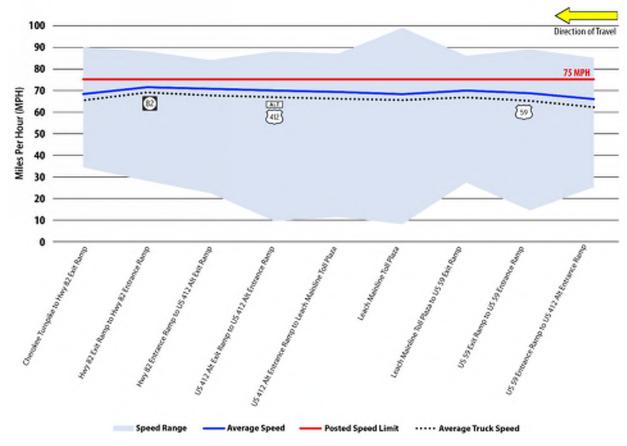
Figure A- 20: Cherokee WB PM Travel Speeds

Westbound evening peak period traffic between the hours of 4 PM to 6 PM is presented in this section. The posted speed limit in the Cherokee segment is 75 mph. Passenger vehicle and truck speeds remain steady at around 70 mph along the entire segment. Truck speeds are 2 to 3 mph lower across the segment but increase and decrease at the same rate as passenger vehicles.

The average passenger car and truck speeds along the Cherokee Turnpike in the westbound direction during the PM peak hour is between 67 and 71 mph from U.S. 412 Alt/U.S. 59 exit ramp to Highway 82 entrance ramp/U.S. 412. The data shows that westbound speeds range from 9 to 97 mph in this planning segment.

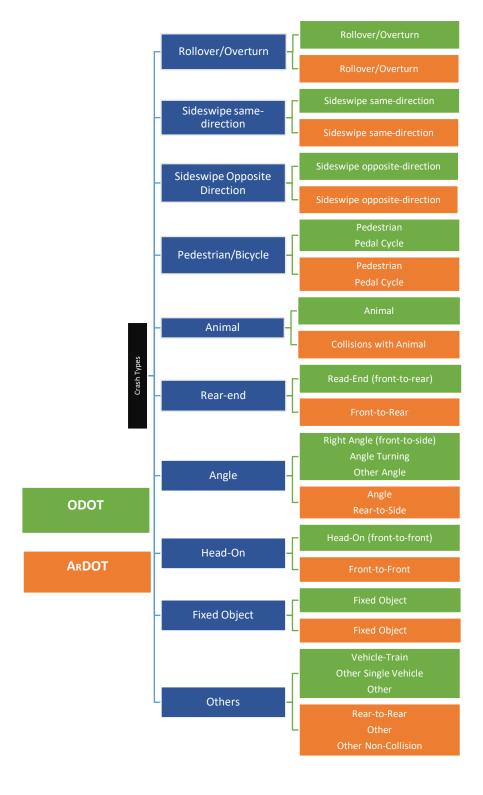
Figure 2: Crash Type Categories

Figure 2 shows how crash-type fields were consolidated. The "Type of Collision (Derived)" data field from the ODOT database and the "Manner of Collision" data field from the ARDOT dataset was used to categorize the crash types. It is important to note that the "First Harmful Event" data field was used to specify the Fixed Objects, Rollover /Overturn, Pedestrian/Bicycle, and Animal crashes in the ARDOT crash data.

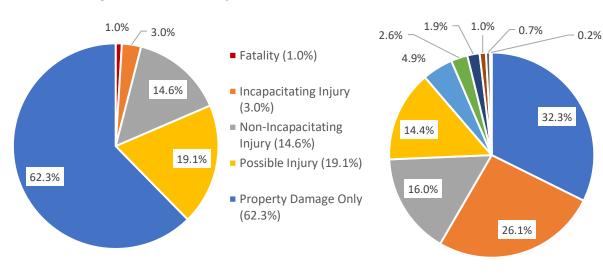
Figure 3: Crash Type - U.S. 412

A total of 4,863 crashes occurred along U.S. 412 corridor within the project study limits. Of the 4,861 crashes, 3,032 crashes (~62%) resulted in property damage only, 1,784 crashes (~37%) caused some form of injury to vehicle occupants, and 47 crashes (1%) resulted in fatalities (**Figure 3**). Fixed object collisions were the main crash types, accounting for approximately 32% (1,572 crashes) of all reported crashes within the project limit followed by rear-end collisions which represent 26% (1,267 crashes) of all crashes (**Figure 4**). The remaining 2,024 crashes (~42%) were associated with sideswipe same-direction collisions, angle collisions, rollovers/overturns, animals, pedestrians, head-on, sideswipe opposite-directions, and other crash types

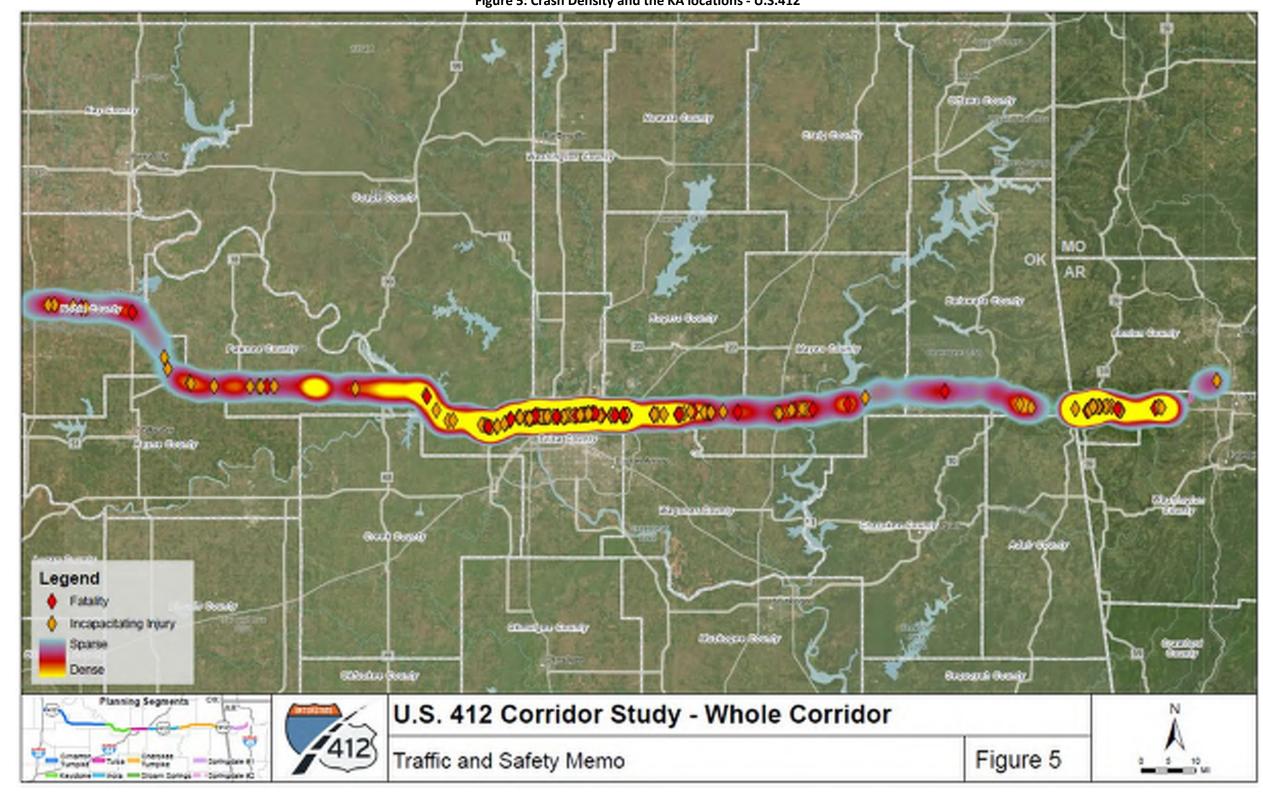
Figure 5: Crash Density and the KA locations - U.S.412

Crash density and the locations of KA crashes along U.S. 412 are presented in **Figure 5**. Among the planning segments, Tulsa, and east portions of Keystone in Oklahoma, and all of Siloam Springs in Arkansas

experienced the highest concentration of crashes. Similarly, KA crashes were concentrated from N 129 th Avenue to OK-66 in Oklahoma and Siloam Springs in Arkansas.

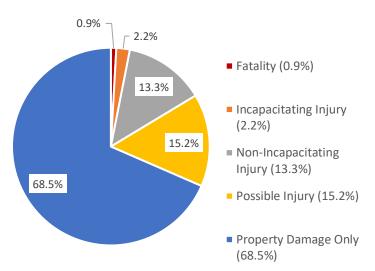
Figure 10: Crash Type - Keystone

There were 904 crashes that occurred along this planning segment, accounting for approximately 19% of all crashes (4,863 crashes) reported along U.S. 412 within the project study limits. Of the 904 crashes reported, 619 crashes (~69% of all crashes) resulted in property damage only, 277 crashes (~31% of all crashes) caused some form of injury to vehicle occupants, and eight crashes (~1% of all crashes) resulted in fatalities (Figure 9). Fixed objects collisions were the predominant crash types, accounting for approximately 48% (431 crashes) of all reported collisions in the planning segment followed by rear-end collisions (185 crashes, ~21%) and sideswipe same-direction collisions (131 crashes, ~15%). The remaining 157 crashes (~17%) resulted from angle collisions, rollovers/overturns, pedestrians/bicycles, animals, and other types of collisions. (Figure 10). Approximately 44% of fixed object collisions (189 collisions) resulted from collisions with barriers suggesting the presence of problems associate with roadway design.
